GROUP ELE	MODEL 2021MY K5 (DL3a) Sorento (MQ4) and Hybrid (MQ4 HEV)
	NUMBER 229 (Rev 3, 04/09/2021)	DATE January 2021

TECHNICAL SERVICE BULLETIN

**SUBJECT: DISPLAY AUDIO 2.0 VALUE SOFTWARE UPDATE
FOR WIRELESS CARPLAY IMPROVEMENT**

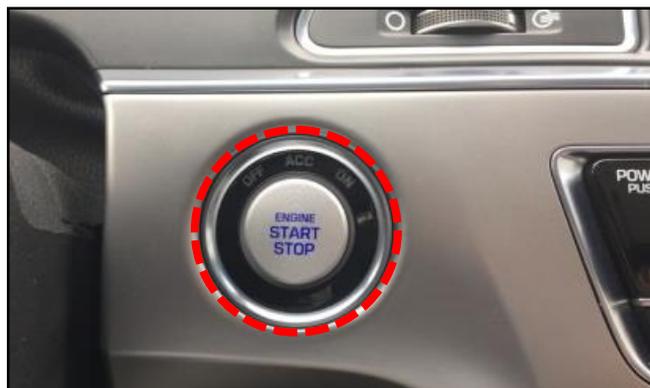
1. Press the 'Start' button to ignition 'ON'.

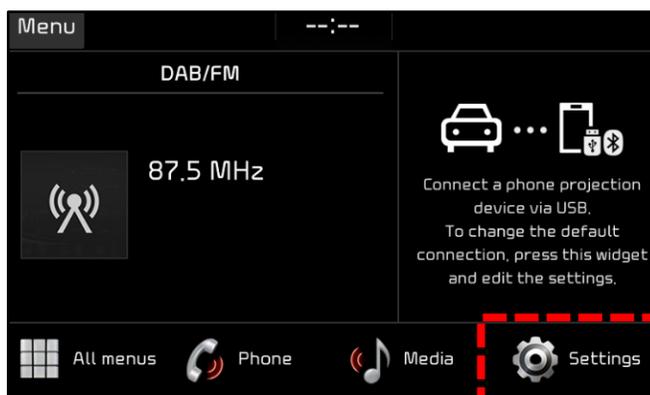
2. Press 'Settings' on the head unit.

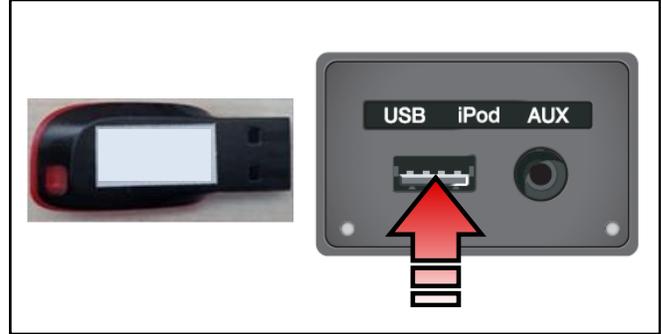
5. Insert USB Flash Drive into the vehicle's USB Port. (Location will vary by model)
